Diploma Thesis for Civil Engineers

Earthquake Safety of Large Wine Tanks in Seismic Regions (Chile)

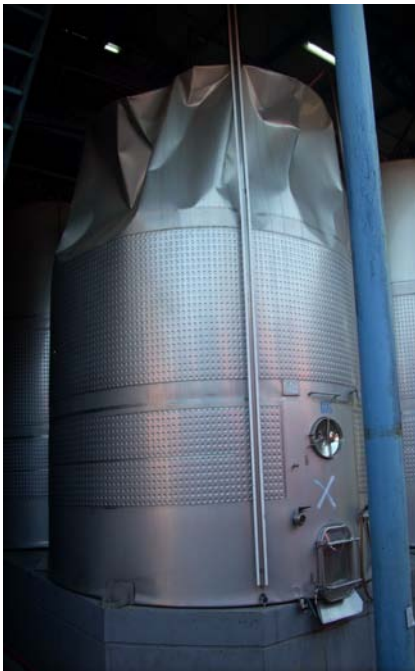
Figure 1. Buckled Tank

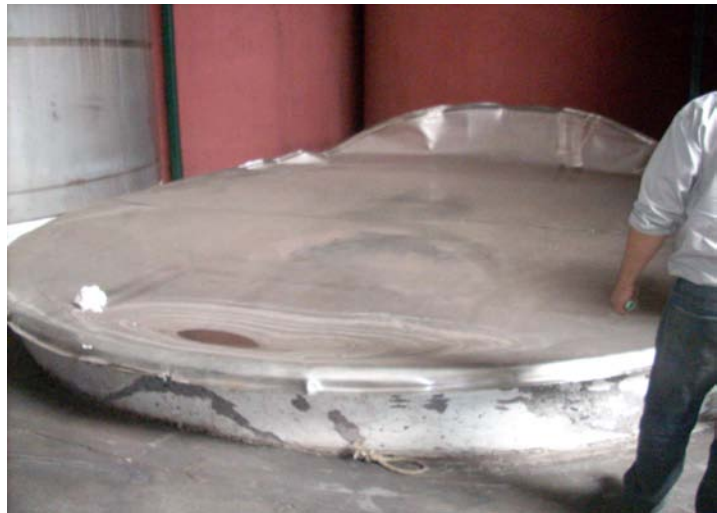
Figure 2. Failure of bottom to mantle welding of tank

1. The larger tanks are circular tanks supported by reinforced concrete mats, but they are not totally clamped. They can be with some restrictions in the horizontal displacement and some of them are free to slide.
2. The tanks usually have openings for cleaning them that are closed by doors or hatches that open laterally in the lower part of the tank. If the reinforcement of this area is not strong enough, the door opens and the wine is emptied very fast which leads to an upper buckling of the tank, Figure 1 and 3.
3. Another problem is the overall stability of the tank which can overturn causing its total loss.
4. Failures also can occur because of badly designed welds as can be seen in Figure 2. In this picture a total failure of the bottom to mantle weld is shown. Only the bottom part has remained in position over the mat.

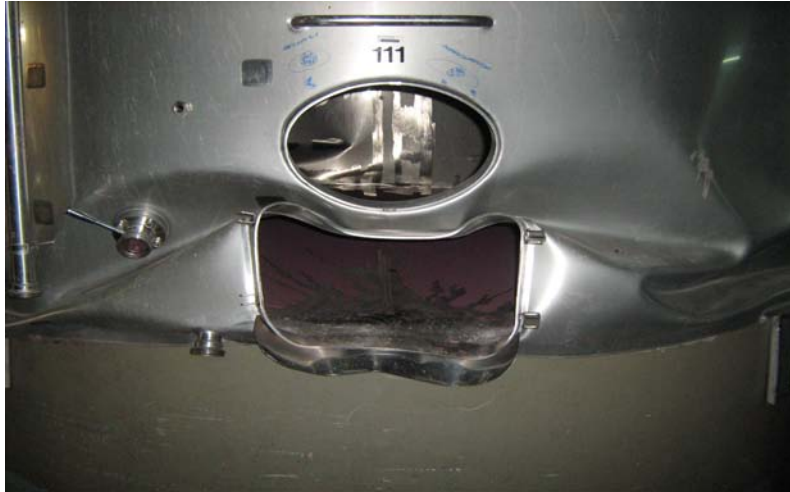
Figure 3. Failure of the cleaning doors.
