Diploma Thesis for Civil Engineers

Earthquake Safety of Large Wine Tanks in Seismic Regions (Chile)

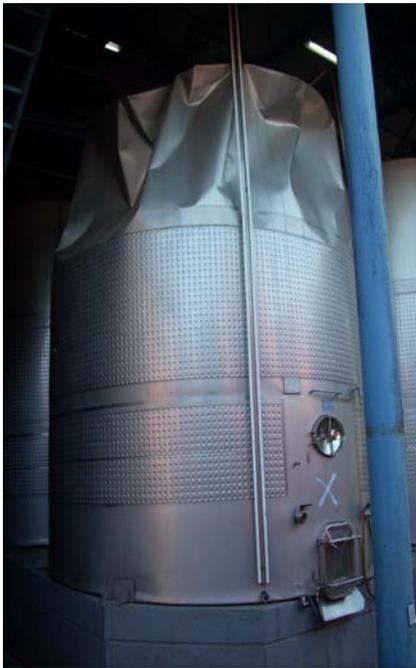
Figure 1. Buckled Tank

1. The larger tanks are circular tanks supported by reinforced concrete mats, but they are not totally clamped. They can be with some restrictions in the horizontal displacement and some of them are free to slide.
2. The tanks usually have openings for cleaning them that are closed by doors or hatches that open laterally in the lower part of the tank. If the reinforcement of this area is not strong enough, the door opens and the wine is emptied very fast which leads to an upper buckling of the tank, Figure 1 and 3.
3. Another problem is the overall stability of the tank which can overturn causing its total loss.
4. Failures also can occur because of badly designed welds as can be seen in Figure 2. In this picture a total failure of the bottom to mantle weld is shown. Only the bottom part has remained in position over the mat.

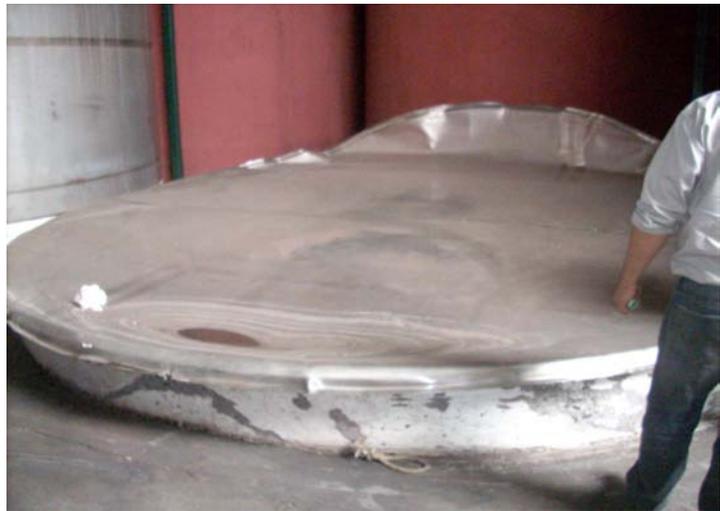
Figure 2. Failure of bottom to mantle welding of tank

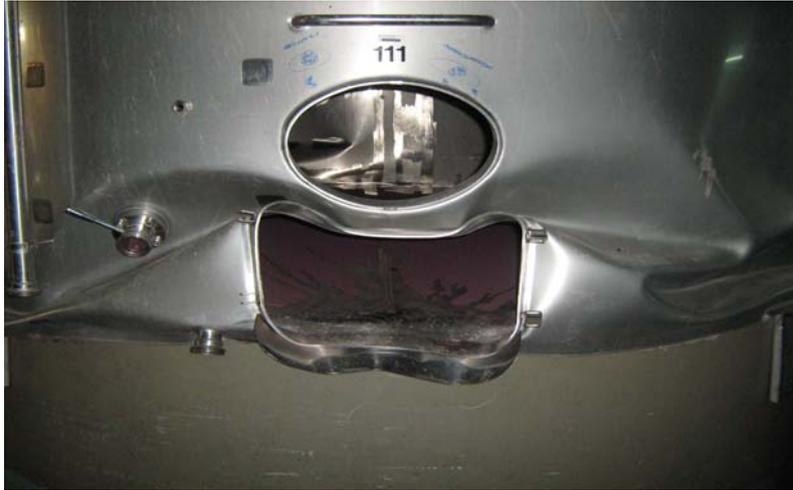
Figure 3. Failure of the cleaning doors.
